# Assessment of High-Temperature Hydrogen Attack Using Advanced Ultrasonic Array Techniques

## ABSTRACT

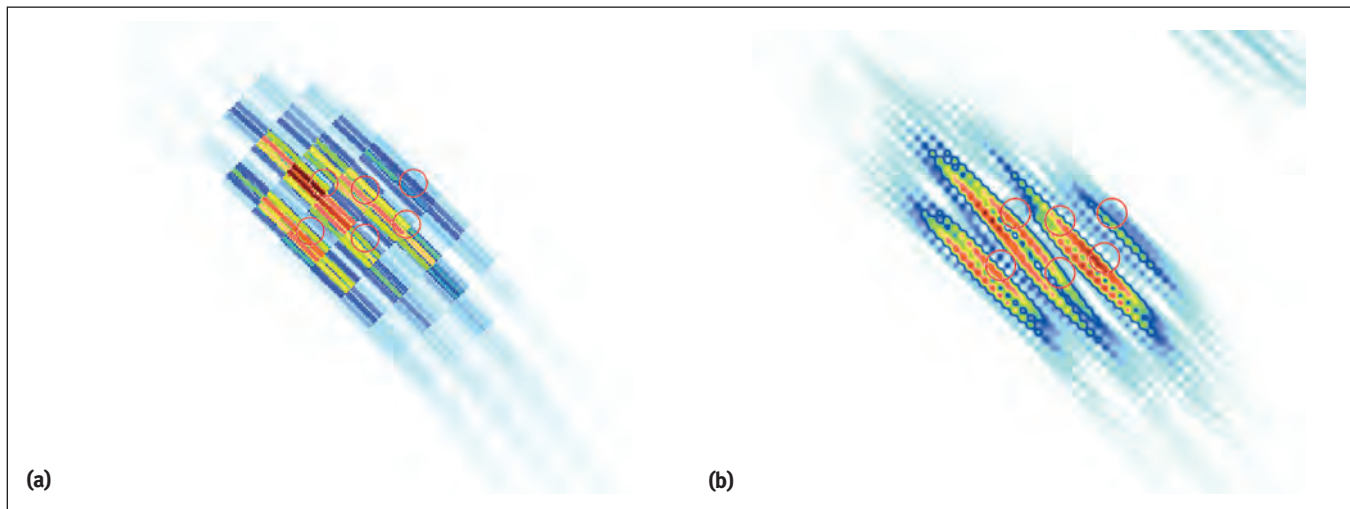
Figure 1. 10 MHz shear wave beam interactions with a cluster of six SDHs: (a) PAUT; (b) FMC/TFM TT.

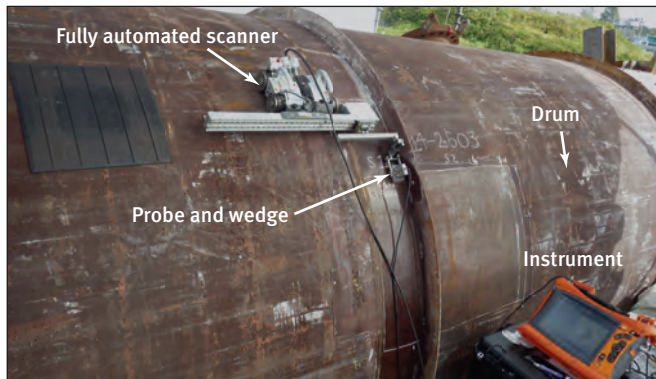
Figure 2. Setup for fully automated PAUT and FMC/TFM.

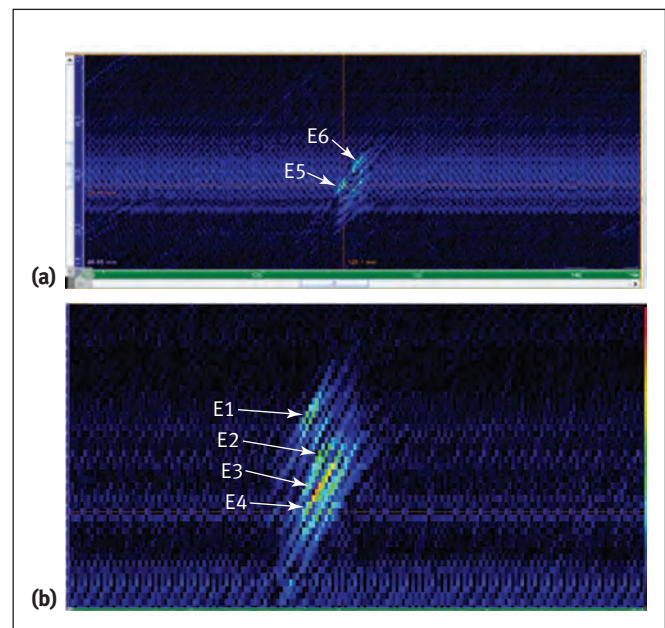
Figure 3. 10 MHz TFM TT imaging of clustered micromachined defects: (a) skew 90; (b) skew 270.

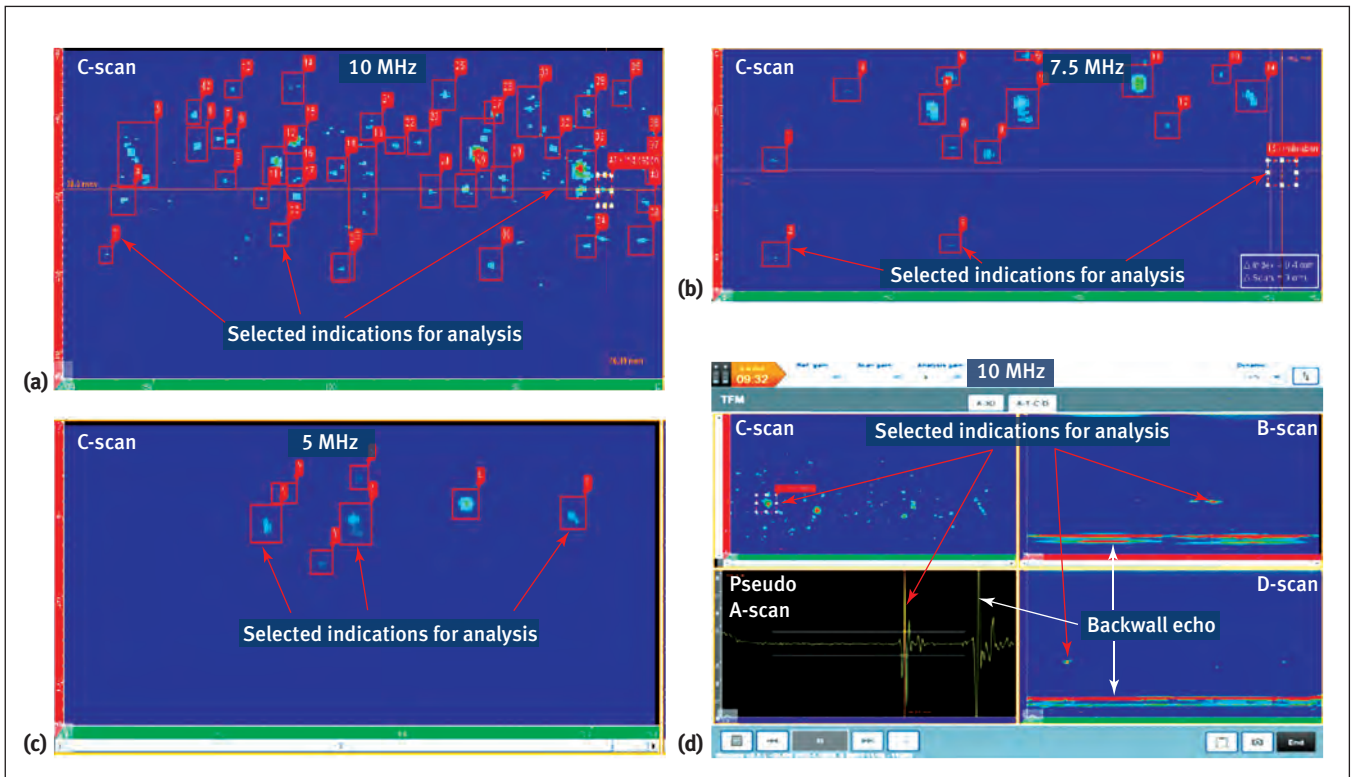
Figure 4. FMC/TFM LL imaging of damage block: (a) 10 MHz projected C-scan; (b) 7.5 MHz projected C-scan; (c) 5 MHz projected C-scan; (d) 10 MHz split screen imaging of selected indication showing projected C-scan, single-plane B-scan, single-plane D-scan, and pseudo A-scan.

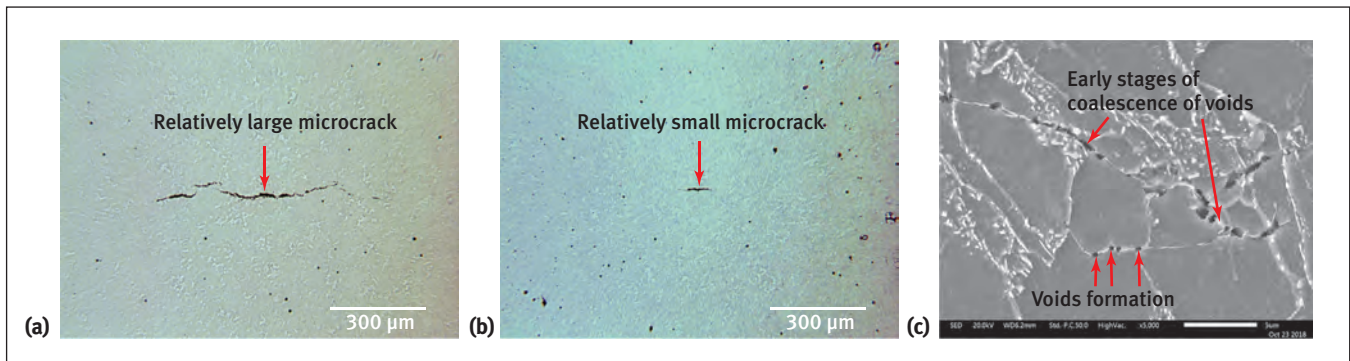
**Figure 5. Optical microscopy and SEM imaging of synthetic HTHA damage: (a) fissures forming relatively large microcrack indicative of HTHA damage (~100 $\times$ , as polished); (b) fissures forming small microcrack indicative of HTHA damage (~100 $\times$ , as polished); (c) damage feature showing severe dissolution of grain boundaries, grain boundary single void formation, and early stages of coalescence of voids in the periphery of the main feature, indicative of HTHA volumetric damage (~5000 $\times$ , as polished).**

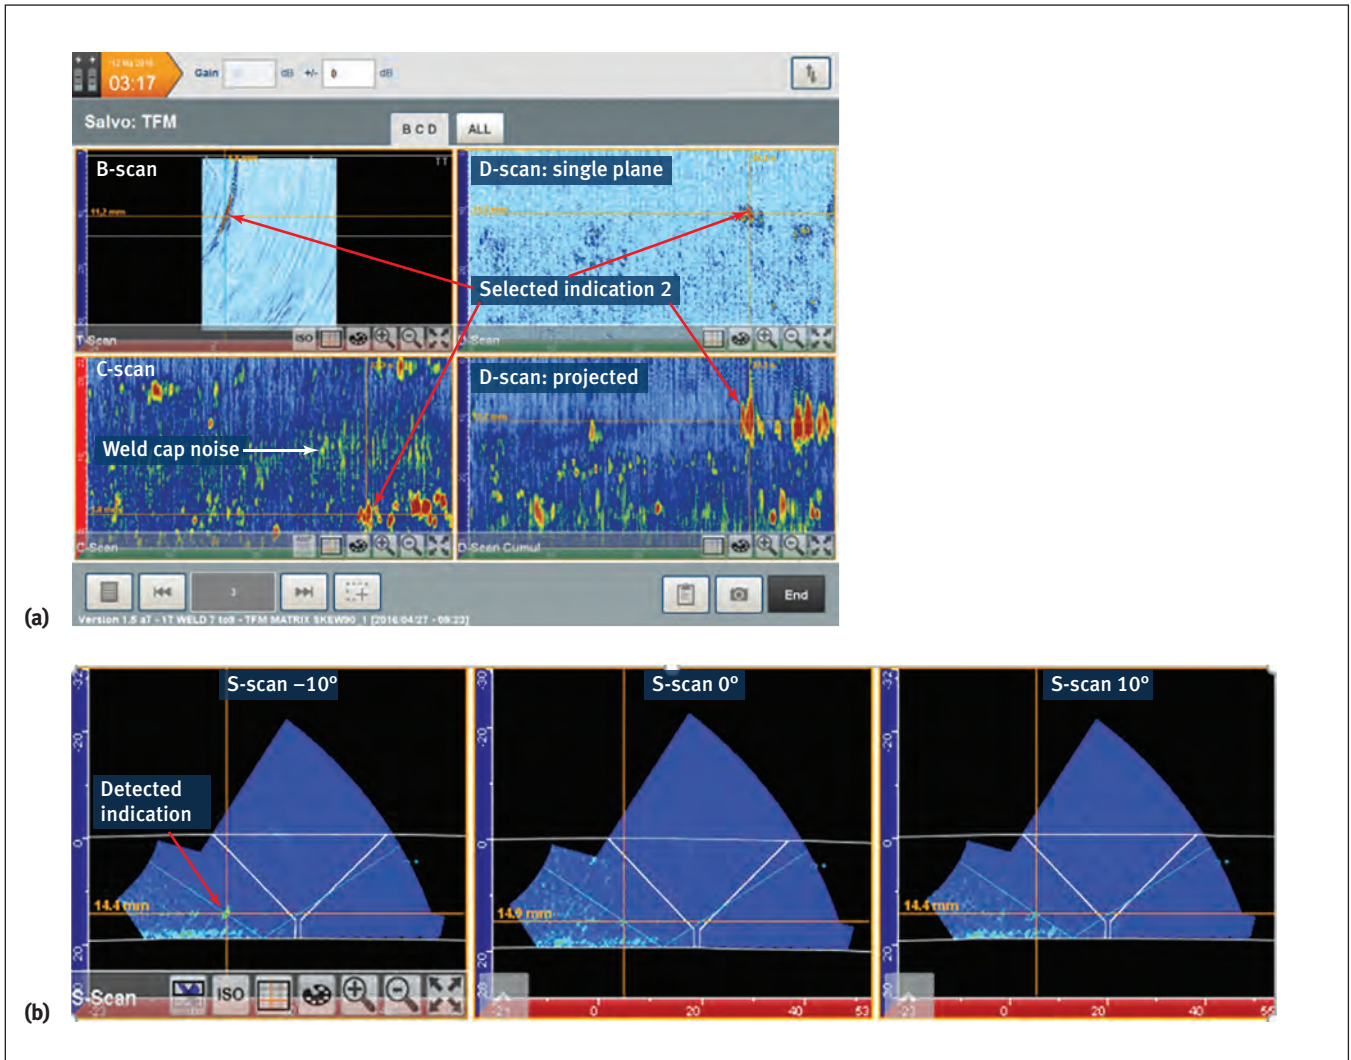
Figure 6. Imaging of HTHA weld damage using 10 MHz TT FMC/TFM and PAUT techniques: (a) linear probe split screen views of indication 2; (b) indication of potential HTHA damage detected in the breaking areas using matrix probe and S-scan at skew  $-10^\circ$ .

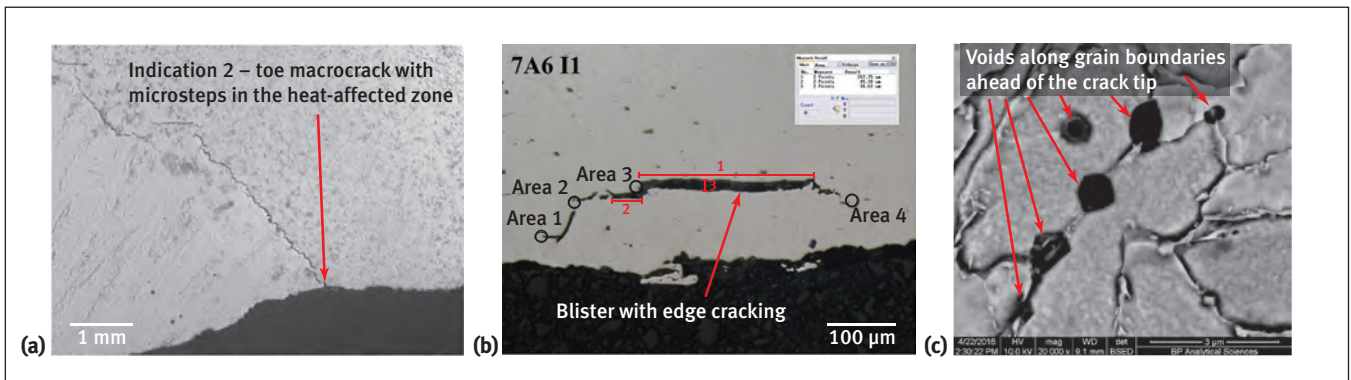
Figure 7. Weld damage validation using optical metallography and SEM: (a) root cracking in the heat-affected zone indicative of HTHA damage ( $\sim 20\times$ , nital etched); (b) blister with edge cracking ( $\sim 40\times$ , nital etched); (c) voids along grain boundaries ahead of the crack tip ( $\sim 20\,000\times$ , nital etched).

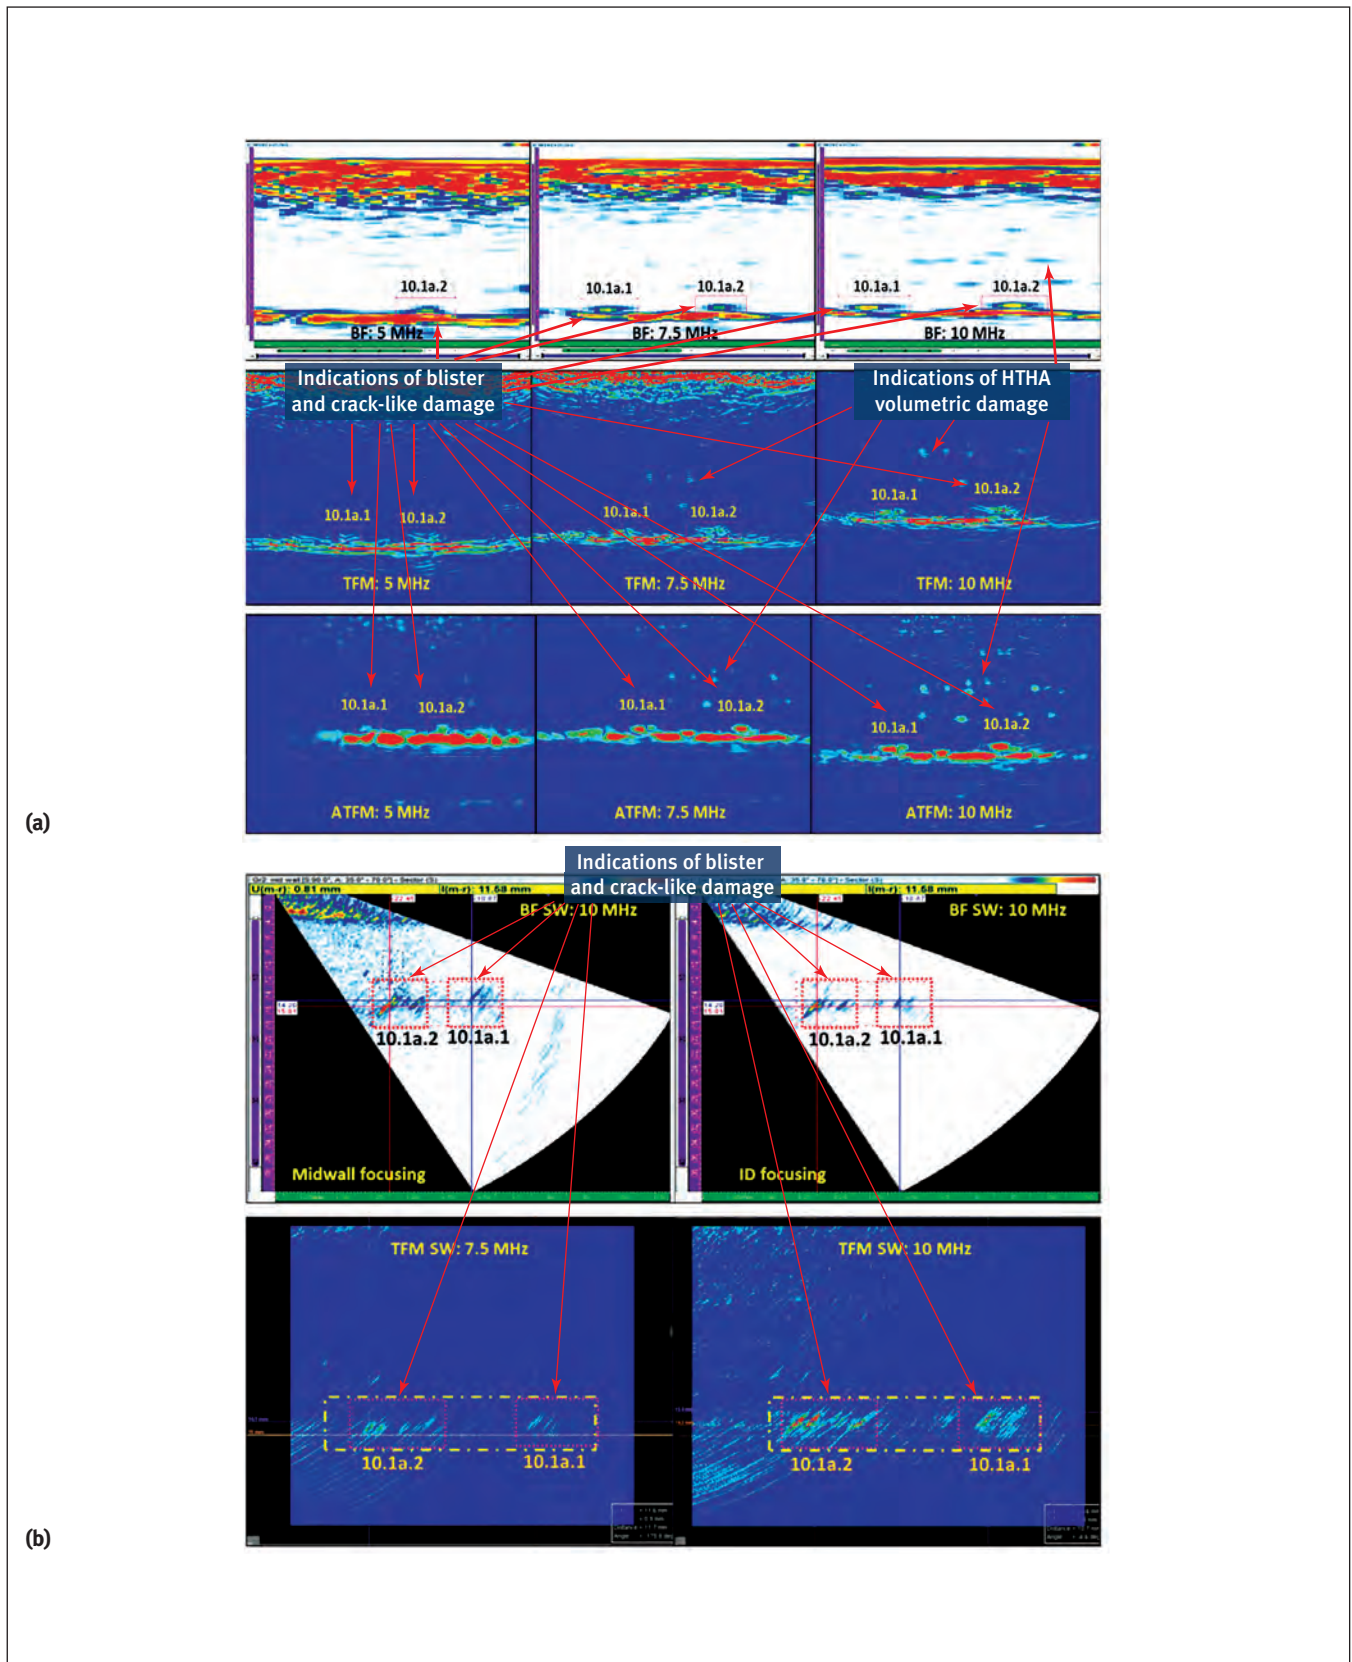
Figure 8. Imaging of indication 10.1a.1 and 10.1a.2: (a) PAUT straight-beam and FMC/TFM/ATFM LL B-scans comparison; (b) comparison of PAUT S-scans and FMC/TFM TT B-scans using shear wave techniques.

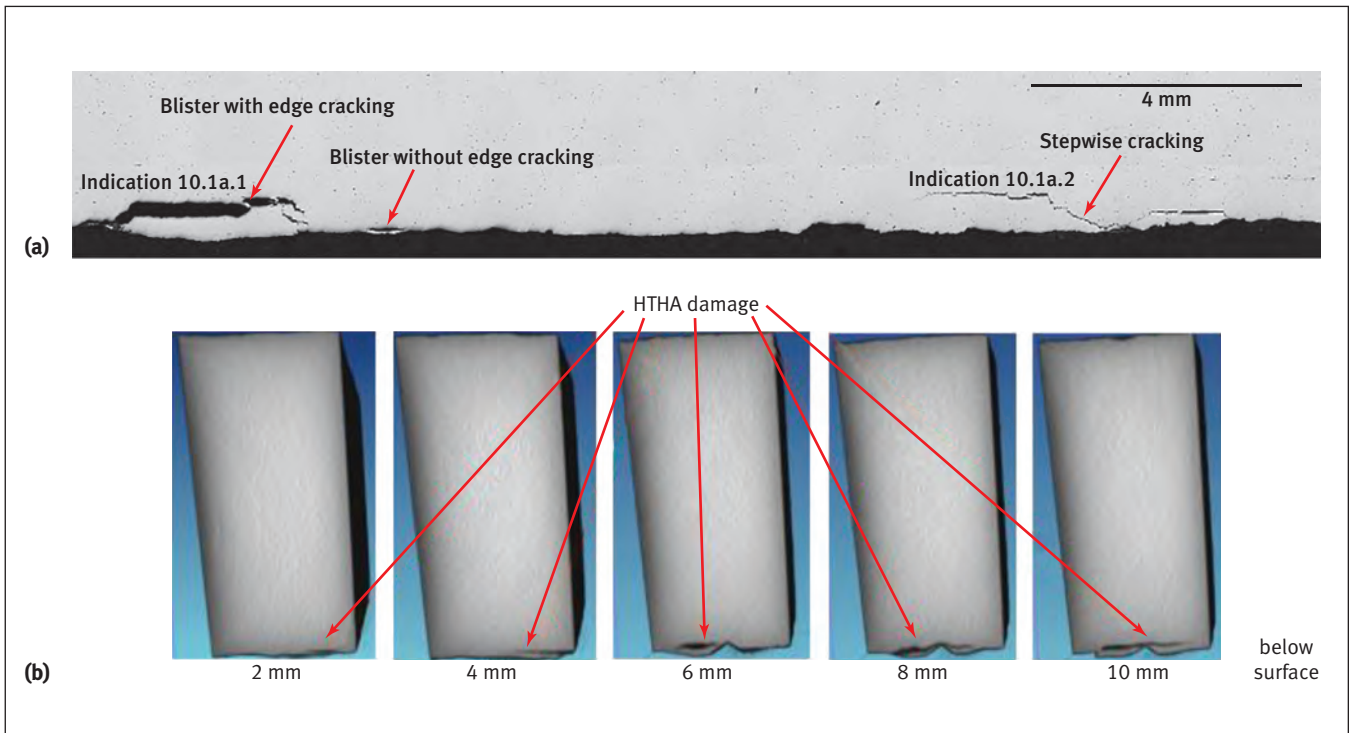
Figure 9. Metallographic and CT images: (a) indications 10.1a.1 and 10.1a.2,  $\sim 10\times$ , as polished; (b) CT images of indication 10.1a.2 from 2 to 10 mm below the polished surface of the mount.

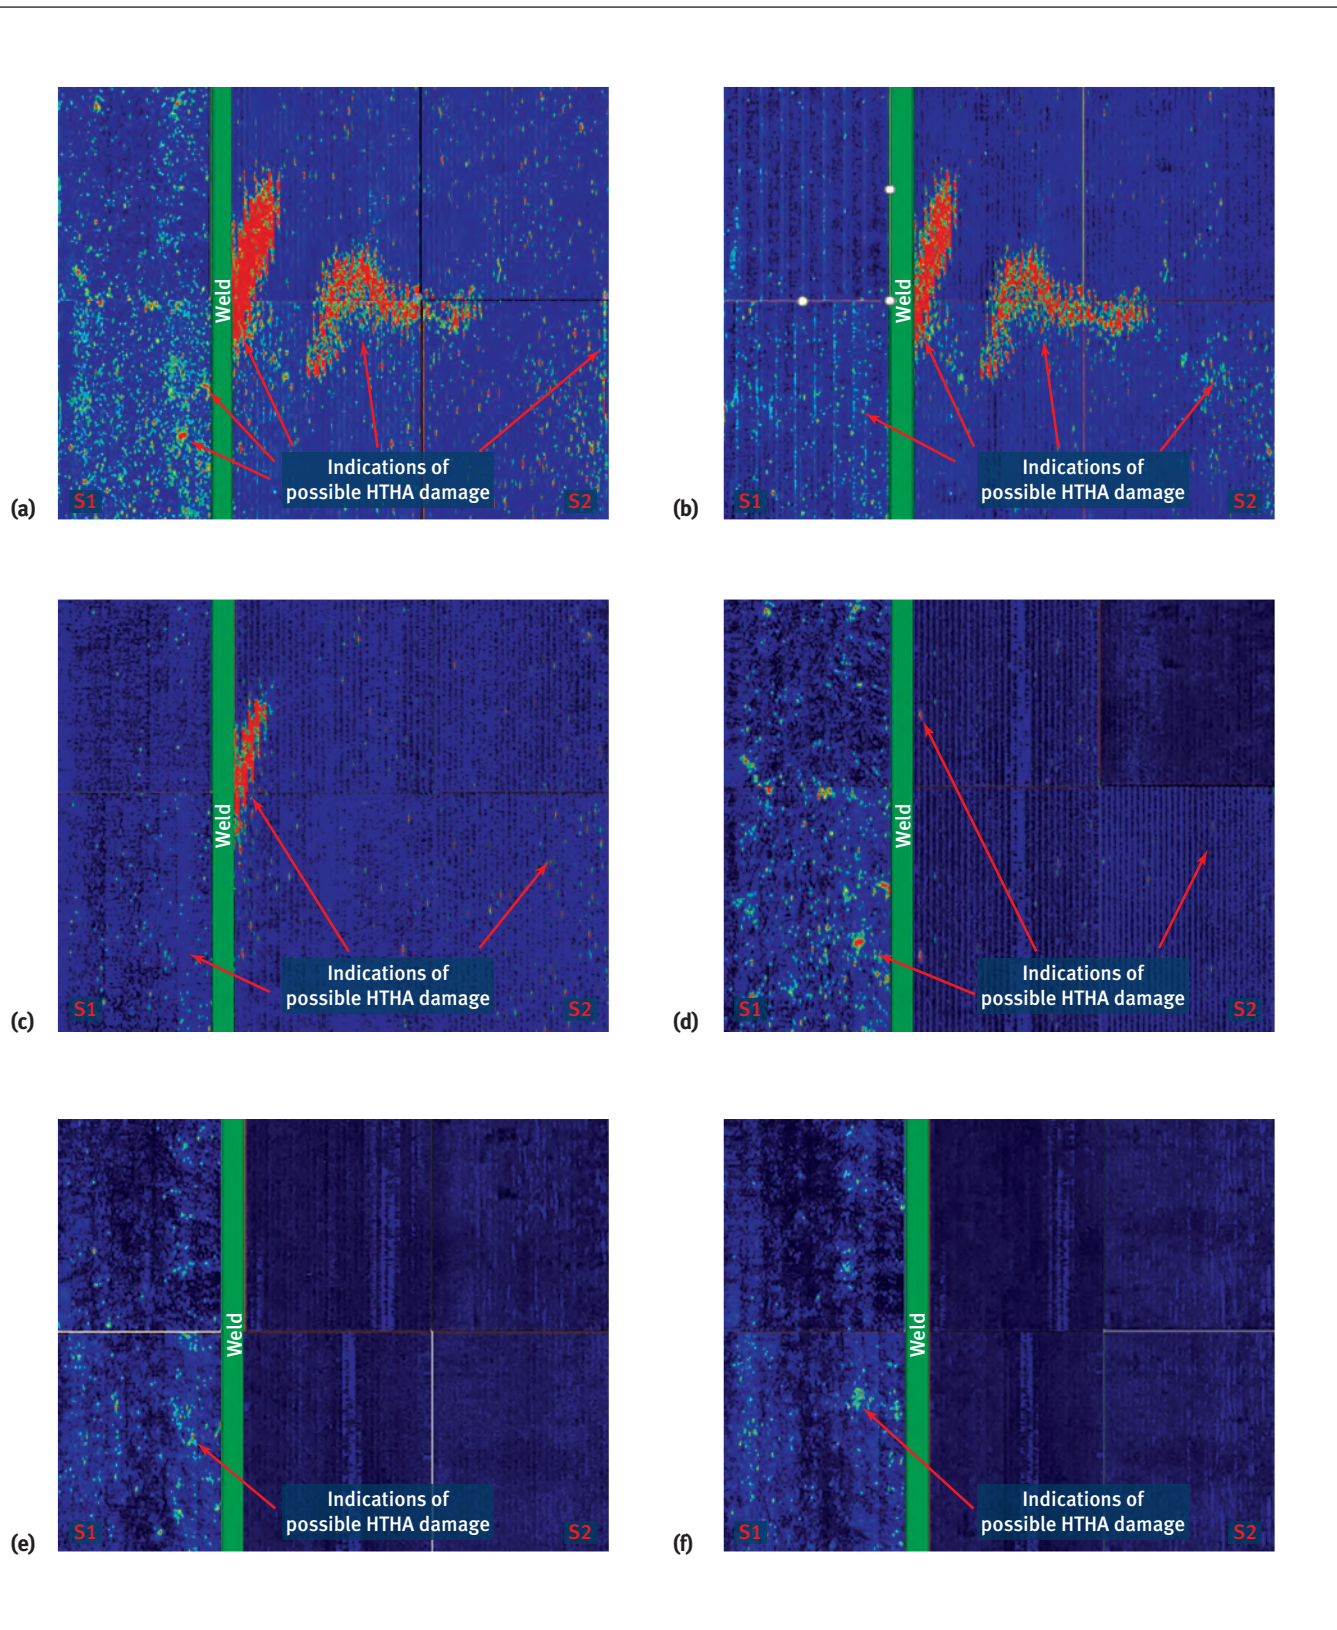
Figure 10. FMC/TFM imaging and HTHA validation of localized and through-wall distribution for the south section of drum: (a) 0% to 88% wall thickness (34 to 5 mm); (b) 0% to 5% wall thickness (34 to 32.3 mm); (c) 5% to 10% wall thickness (32.3 to 30.6 mm); (d) 10% to 20% wall thickness (30.6 to 27.2 mm); (e) 20% to 30% wall thickness (27.2 to 23.2 mm); (f) 30% to 50% wall thickness (23.2 to 17 mm).

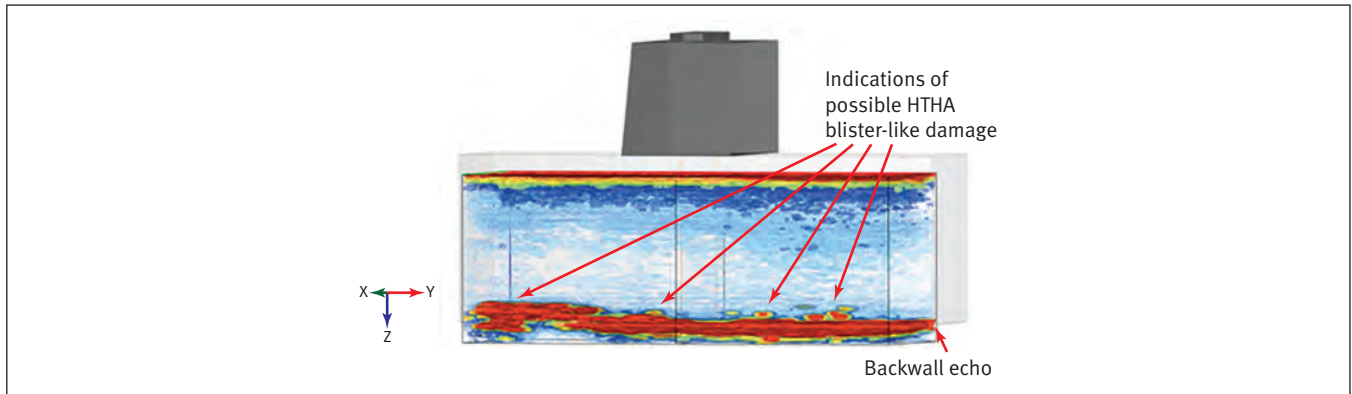
Figure 11. 3D imaging of possible blister-like damage.

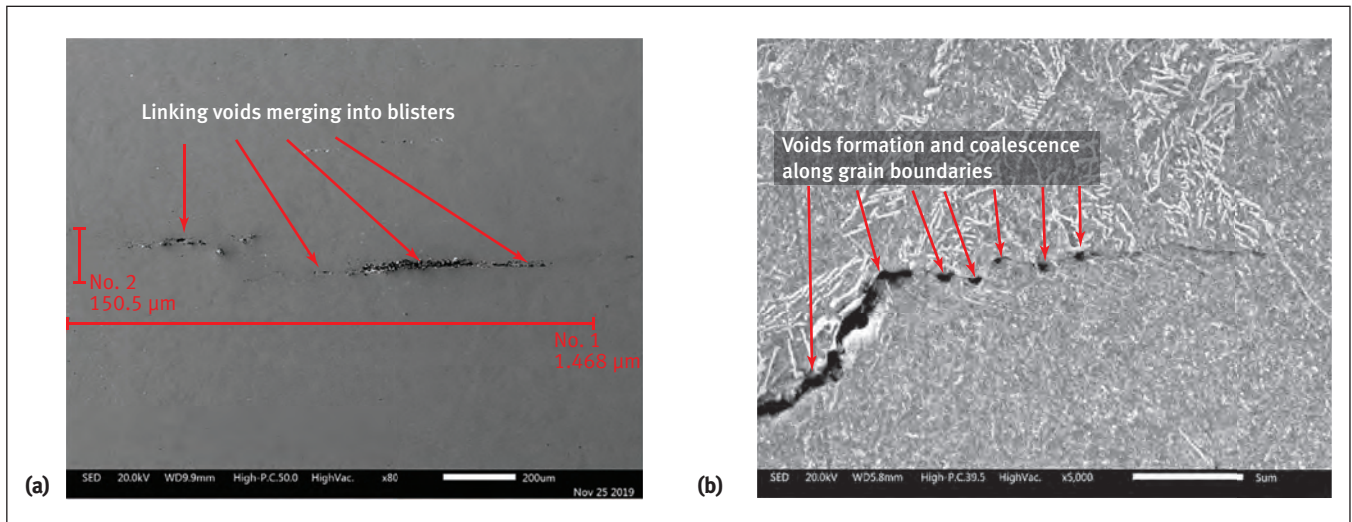
Figure 12. Optical metallography: (a) linking voids merging into blisters, ~80 $\times$ , as polished; (b) SEM validation of early-stage HTHA volumetric damage, ~5000 $\times$ , nital etched.

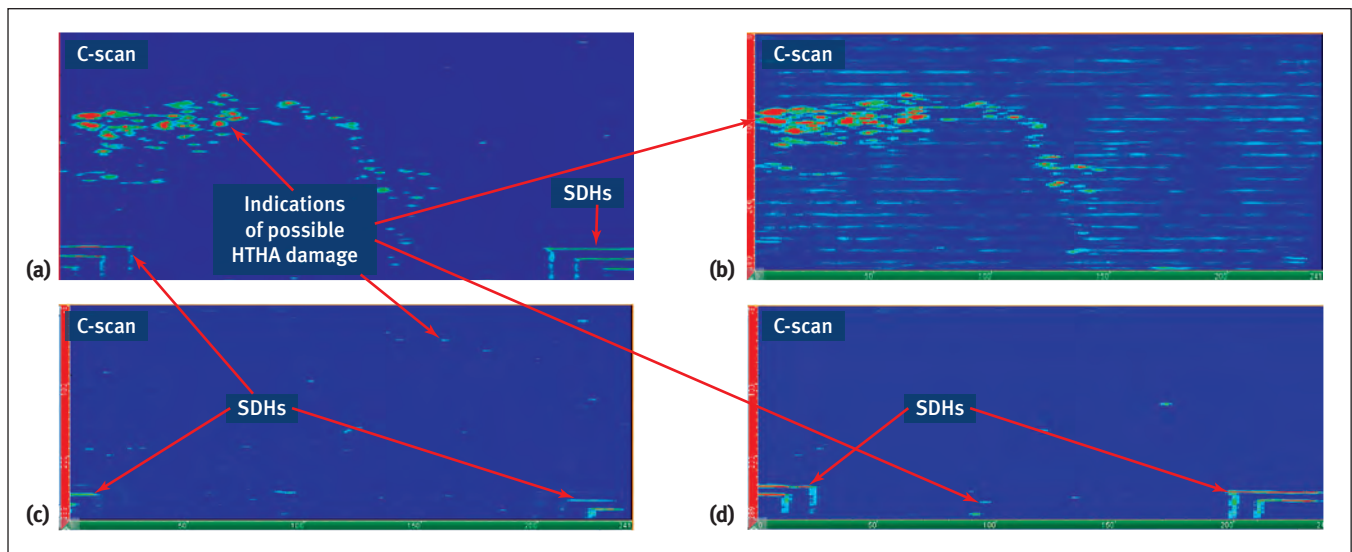
Figure 13. FMC/TFM imaging and HTHA validation raster C-scan imaging of possible HTHA damage localized and through-wall distribution for the north section of drum: (a) 0% to 70% wall thickness (34 to 10 mm); (b) 0% to 5% wall thickness (34 to 32.3 mm); (c) 5% to 10% wall thickness (32.3 to 30.6 mm); (d) 10% to 20% wall thickness (30.6 to 17 mm).

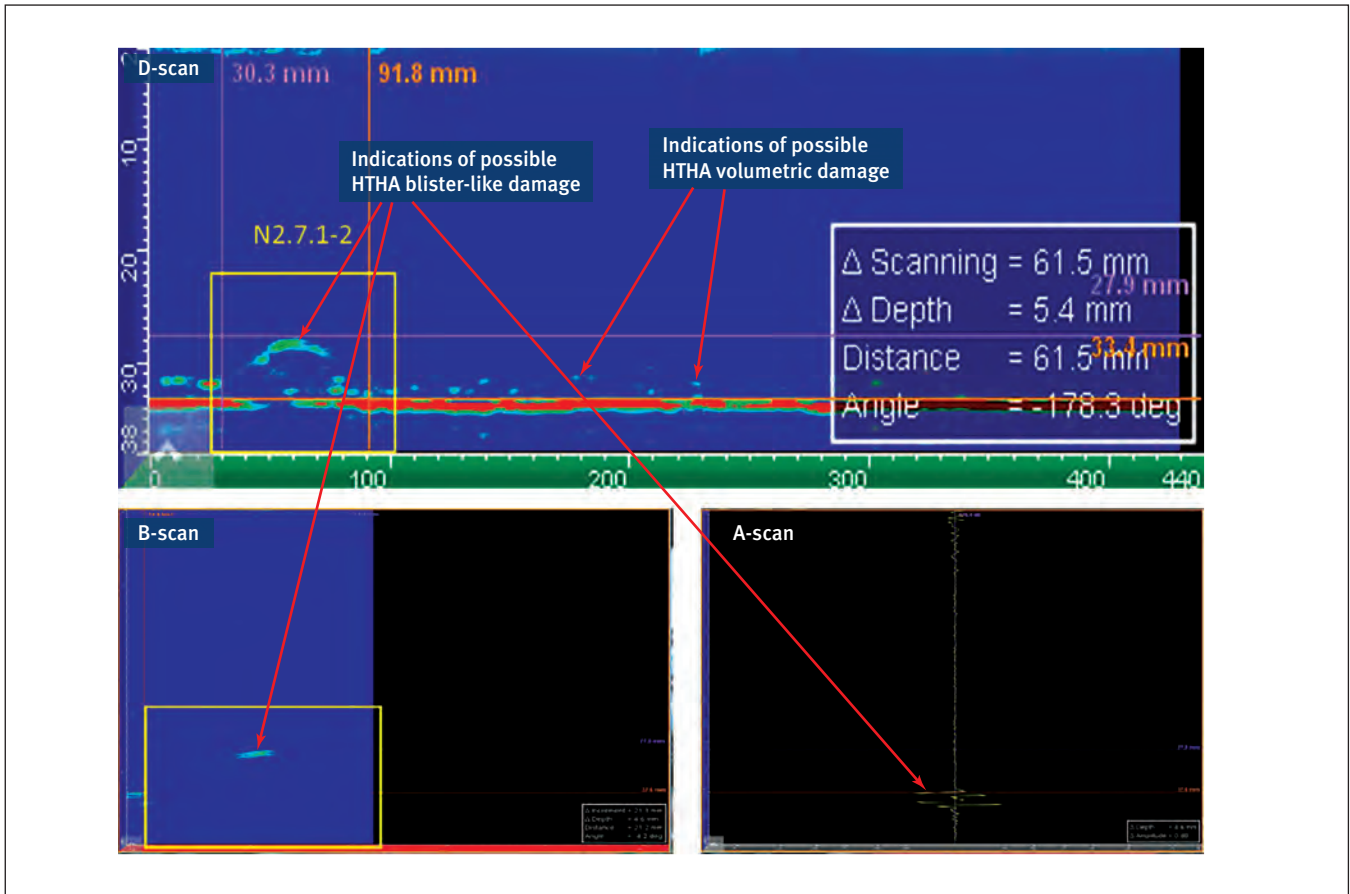
Figure 14. Line scan imaging of possible blistering with sharp crack-like edges.

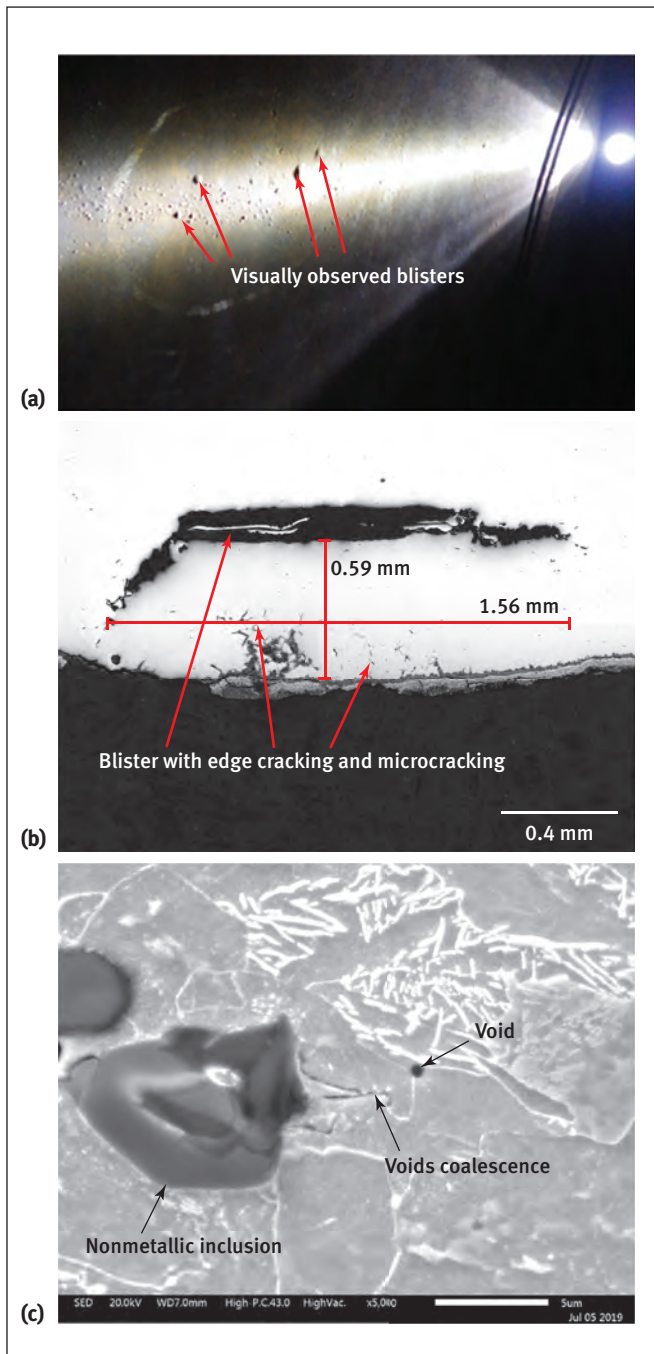
**Figure 15. Potential indications of HTHA: (a) visual validation of typical blister bulging; (b) optical metallography of blistering with sharp crack-like edges, ~50 $\times$ , as polished; (c) SEM of nonmetallic inclusions and evidence of early-stage HTHA damage of void formation and voids coalescence, ~5000 $\times$ , nital etched.**
